**Flood Control Project Maintenance  
Levee Inspections****LMA District Cover Sheet****Spring 2014 Levee Inspection Results****Sacramento Maintenance Yard East Levee Yolo Bypass**

**Spring 2014 Levee Inspection Results**

**Sacramento Maintenance Yard East Levee Yolo Bypass**

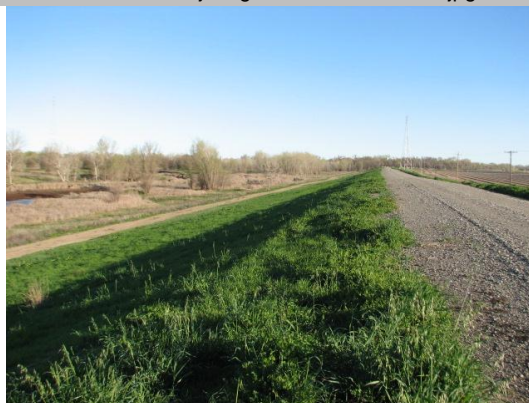
Photo 1 of 1 : johngw\_s\_20140317\_631.jpg

LM Start	0.00	Rating **	A	Issue No.	56
LM End	2.00	Issue Type +	Ma	Location *	WS
Category	Earthen Levee			GPS Latitude/Longitude	
				Start	End
Item	Vegetation			38.763833 °	38.735970 °
				-121.635498 °	-121.633663 °
DWR ID	DWR_ST0004_01_s _ 2014_56				
Action/Comments					
Control annual grass and weeds on the levee slopes and easements.

The vegetation on slope is 75% grasses and complies with standards.  
Spring 2014

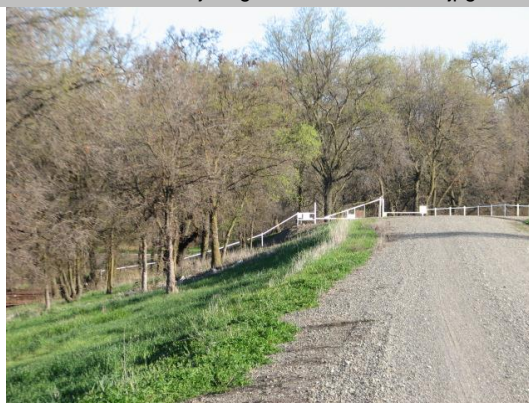
Photo 1 of 1 : johngw\_s\_20140317\_633.jpg

LM Start	0.01	Rating **	A/W	Issue No.	11
LM End	0.19	Issue Type +	Ma	Location *	WS
Category	Earthen Levee			GPS Latitude/Longitude	
				Start	End
Item	Vegetation			38.765295 °	38.762751 °
				-121.635085 °	-121.635422 °
DWR ID	DWR_ST0004_01_f _ 2013_11				
Action/Comments					
Trees / Woody Vegetation

The trees at Fremont Weir need to be monitored for future removal if necessary. Spring 2014

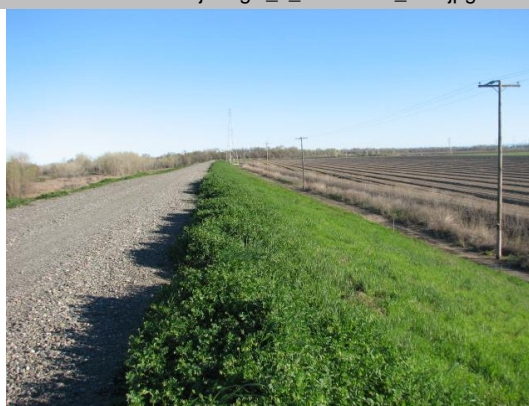
Photo 1 of 1 : johngw\_s\_20140317\_632.jpg

LM Start	0.01	Rating **	A	Issue No.	55
LM End	2.00	Issue Type +	Ma	Location *	LS
Category	Earthen Levee			GPS Latitude/Longitude	
				Start	End
Item	Vegetation			38.765290 °	38.735972 °
				-121.635081 °	-121.633663 °
DWR ID	DWR_ST0004_01_s _ 2014_55				
Action/Comments					
Control annual grass and weeds on the levee slopes and easements.

The vegetation on the slope is 75% grasses and complies with standards. Spring 2014
